Rural Municipality of Lac du Bonnet Accessibility Audit Project: Report of Findings

Prepared by: Left Turn Right Turn Ltd.

Submitted on August 13, 2025

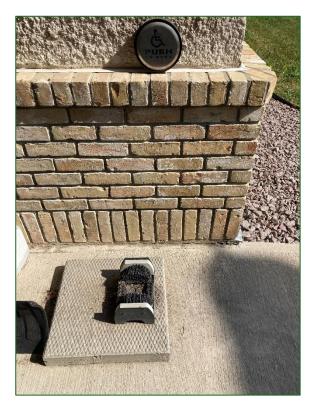
We noted that the automatic door opener on the exterior of the RM's municipal office building has a boot scraper placed directly beneath it. This could create a barrier for a person who needs to stretch over the scraper to reach the button. It could also create a tripping hazard. We suggest moving the boot scraper away from the button and ensuring that both the interior and exterior of the building remain clear of obstacles.

Figure 4 The boot scraper is positioned directly beneath the button for the automatic door opener.

Ensure that building entrances have automatic door openers within safe reach
of the door, and that the entrances are free of obstacles and tripping hazards.

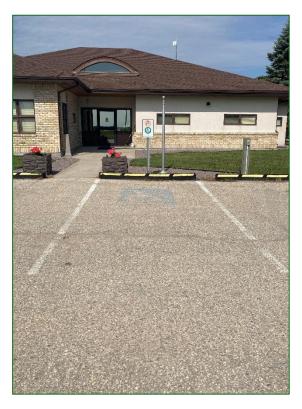
When entering the municipal office, we noticed that the paint in the parking lot pavement has weathered and worn off. The lines marking the spots are still semi-visible, but the icon

denoting the designated accessible parking space has almost disappeared. Even though there is a metal sign directly in front of the spot, we suggest refreshing the paint in order to provide stronger visual cues to visitors that the spot is designated for holders of accessible parking passes.

Figure 6 The painted sign denoting the accessible parking space is very worn. While the sign is still in good condition, refreshing the paint would provide another important visual cue about the space.

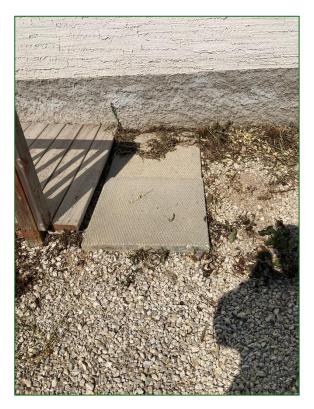
The patio stones at the base of the ramp do not sufficiently connect the end of the ramp with the ground. The ground leading up to the patio stones is also covered in uneven gravel, which would make it difficult for a person using a wheelchair or walker to move across it safely. The plants growing between the rocks could also pose a tripping hazard as they mature. We suggest adding a small threshold ramp that would bridge the gap between the end of the ramp and the ground, and either firmly packing the gravel between the ramp and parking lot or paving a path.

Figure 8 The end of the ramp at the public works office is not fully accessible.

Ensure that ramps and walkways are regularly maintained and free of tripping hazards.

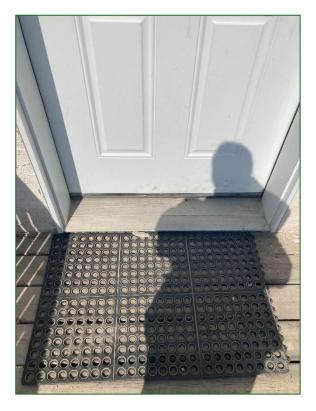
We also noticed that there is a lip on the threshold of the door to the public works office. This could create a tripping hazard or a barrier to people using mobility aids. We suggest adding another threshold ramp here to make access to the building safer for visitors.

Figure 9 The threshold of the door at the public works office could present a tripping hazard.

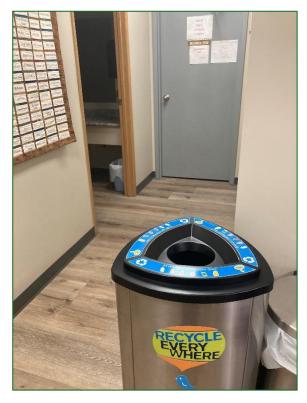
We noticed that while the hallways in the municipal office are wide enough to be accessible, there are some obstacles that might block access for people navigating with a support person or using a wheelchair. For example, the placement of the garbage and recycling cans blocks the corner of the hallway that leads to the washrooms. We suggest finding new places for these bins or replacing them with smaller bins that could fit in the hallway without blocking it. The hallways should then be kept clear of similar kinds of obstacles.

Figure 11 The recycling can is blocking clear access to the hallway leading to the washrooms.

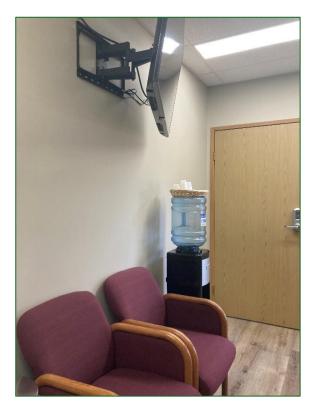
We also noted that the TV screen hanging over the chairs in the hallway could present a head strike hazard, especially for someone who is tall and sitting directly beneath the screen. We suggest either moving the screen away from the seating area or moving the seating area so that it is away from obstacles like the TV.

Figure 12 The TV screen hangs over the seating area in the municipal office hallway.

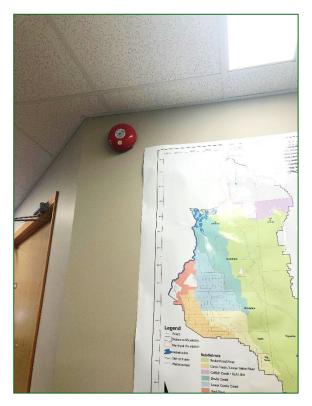
We noticed that the fire alarms at the municipal office do not appear to have visual components. Most fire alarm systems rely only on audio warnings, which makes them inaccessible to people who are deaf or hard-of-hearing. Adding or replacing them with units that have strobe light functions in addition to audio alarms would alert people who are deaf or hard-of-hearing in the event of an emergency. We especially suggest adding audio-visual alarms to enclosed spaces, such as washrooms or offices, where people who are deaf may be alone and without hearing individuals to alert them to an emergency.

Figure 13 The fire alarm system at the municipal office does not appear to have visual/light components.

• Consider adding visual components to emergency alarms in public spaces.

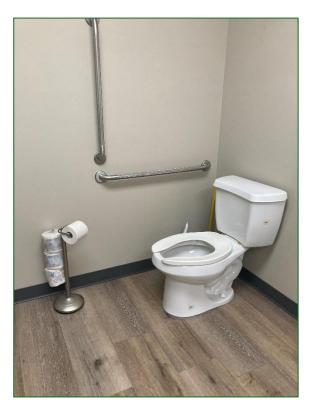
In both washrooms, we noted that the toilet paper holders are free-standing rather than mounted on the wall. They are also placed far from the toilets. A person reaching for the toilet paper could knock over the dispenser or even fall off the toilet. We suggest replacing these dispensers with wall-mounted units within easy reach of the toilet. In the accessible washroom, this may require adjusting the positioning of the grab bars on the wall.

Figure 15 The toilet paper holder in the washroom is free-standing, rather than mounted on the wall.

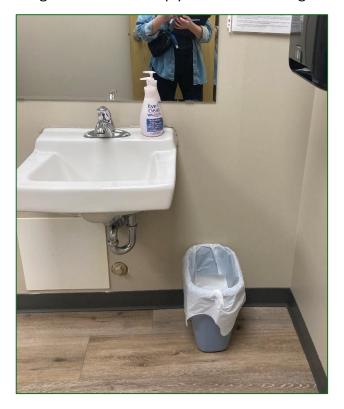
hit their knees on bare pipes or even burn them if the water coming through is hot. We suggest considering adding insulation to the pipe in order to mitigate both risks.

Figure 16 The pipe under the sink in the accessible washroom is uninsulated.

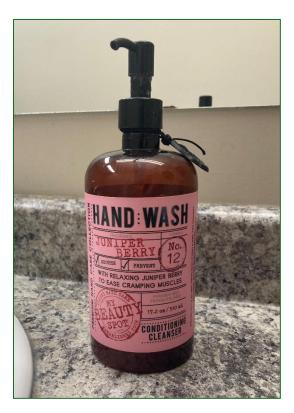
Sensory sensitivities are very common, especially for people who are neurodivergent or who have migraines. Scented products are a common trigger for sensory sensitivities. We noticed that the washrooms in the municipal office were both equipped with scented soaps during our visit. We suggest choosing scent-free soaps, lotions, hand sanitizers, and cleaners wherever possible in order to prevent possible scent-based barriers for people in the building.

Figure 17 Scented products, like this hand soap, are common triggers for people with sensory sensitivities.

Consider using unscented or low-scent products in public spaces wherever possible, including soaps, lotions, and hand sanitizers.

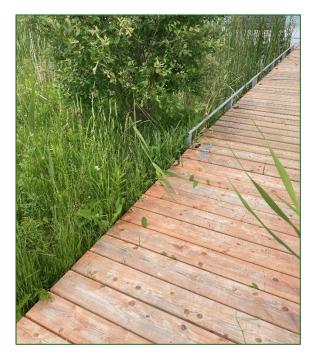
Some ramps or docks have vegetation growing up through their boards. As the leaves and stems continue to grow, they are likely to pose a tripping hazard. This is especially significant for people who use mobility aids, like walkers, or for people who cannot easily lift their feet when walking. We realize that plants are a core component of waterside spaces, and that controlling them is challenging. We suggest that regular maintenance and trimming of the plants would balance the need for accessibility with the needs of the natural environment.

Figure 18 Vegetation is growing through the boards of the dock at the Lac du Bonnet Trout Ponds.

• Ensure that boat launches, including docks and ramps, are regularly maintained and clear of debris, vegetation, and tripping hazards.

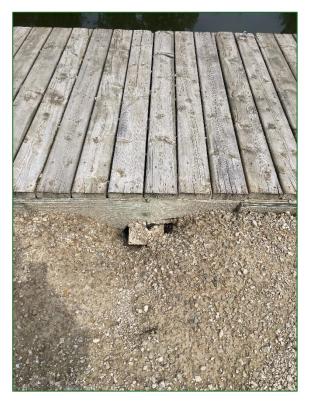
We also noticed spots across the sites where small repairs are needed to prevent tripping hazards. Most frequently, the gravel around the dock or walkway has worn away or become uneven, or an animal has dug a burrow. In other cases, the concrete edges or surfaces have begun to crumble and break down. These issues create tripping hazards for all visitors, but especially for people with disabilities related to vision, mobility, balance, and reaction time. We consider repairs to these features to be urgent and integral to achieving accessibility at the RM's boat launch sites.

Figure 19 At the Osprey Boat Launch, there is a tripping hazard where the gravel has worn away at the dock.

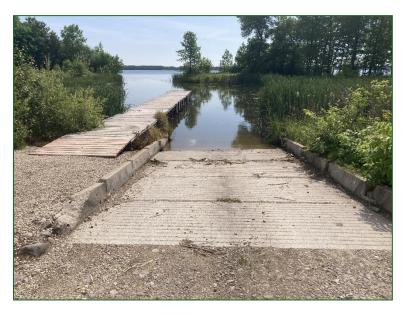
Figure 20 The gravel leading up to the dock at the Wood Duck Boat Launch is uneven at the edge of and leading up to the dock. The concrete edge on the boat launch ramp has also broken and worn away.

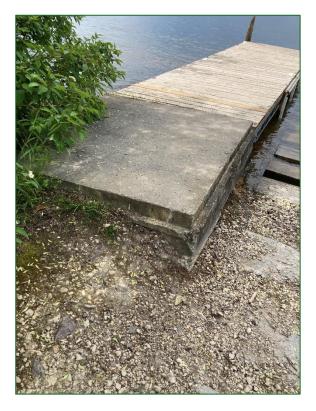
Figure 21 The concrete pad leading up to the dock at the Anderson boat launch does not have a safe access point.

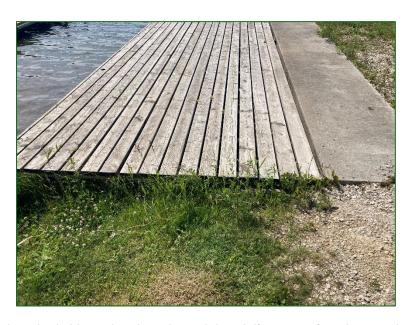
Figure 22 The dock at the LaVerendrye boat launch has foliage growing close to the edge. The gravel path leading to the dock is also uneven, and the gap between the dock and the ground is a tripping hazard.

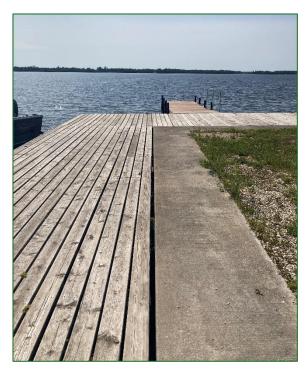
At several sites, we noticed spots where there are unexpected or significant gaps between the boards of the ramps or docks. We also noticed spots where there are gaps between the docks and the ground. Both issues create tripping hazards and barriers for people using mobility aids. These should be repaired or filled promptly to improve safety and accessibility at the boat launches.

Figure 23 There is a significant gap between the dock and the concrete retaining wall at the LaVerendrye boat launch.

• Where there are gaps between boards or blocks on ramps or docks, cover these to prevent tripping hazards. Where there are gaps between the ramps or docks and the ground, add transition ramps.

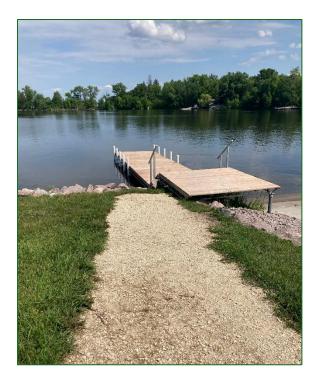
Figure 24 There is a step up between the path and the platform leading to the dock at the Winnipeg River boat launch.

We realize that some of the gaps between the dock boards likely arise because the docks must be disassembled each fall and reassembled each summer. We noticed that some of the gaps are in places where hardware joins two pieces of dock. In these cases, we suggest either covering or filling the gaps with removable pieces of wood level with the surface of the dock. Similarly, we suggest using removable transition ramps to bridge gaps between the docks or ramps and the ground.

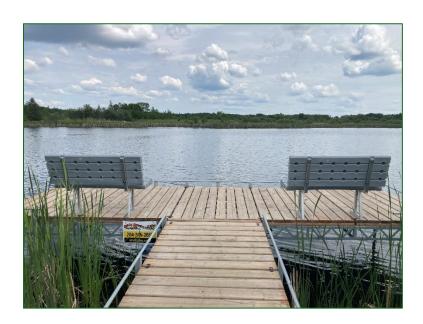
Figure 28 The dock at the Lac du Bonnet Trout Ponds would benefit from a railing behind the benches to prevent falls.

Consider adding railings to walkways and docks where visitors could fall into the water.

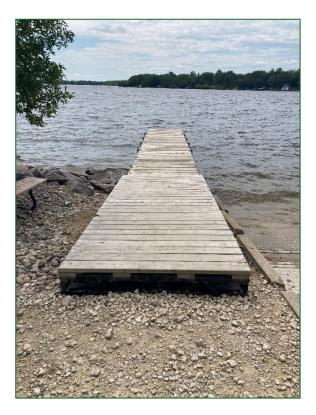
Figure 29 The dock at the Fernwood Boat Launch is long and would benefit from a railing. It also has a step up between the dock and the ground that could be addressed with a transition ramp.

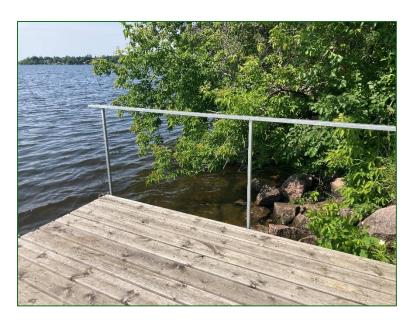
We did notice railings at some of the docks we visited, such as at the LaVerendrye site and some of the docks at the Lac du Bonnet Trout Ponds. These railings could be improved in the future by installing cross bars that would prevent a person of shorter stature from slipping under the top rail. We also suggest considering railings with cross bars closer to the ground, which would help people with low vision who use white canes to more easily identify the edges of the docks.

Figure 30 The dock at the LaVerendrye boat launch has a railing, but the railing does not have cross bars.

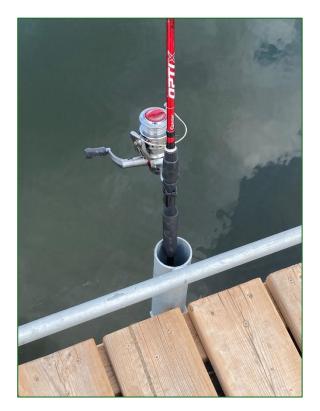
We noticed at some sites that fishing rod holders have been installed into the edges of the docks. These are very helpful for people who cannot hold a fishing rod tightly or for prolonged periods, or who require additional support in order to reel in a catch. However, we noted that all the fishing rod holders are located at the same level as the docks. These could be difficult to access for people with disabilities related to balance, dexterity, or coordination. To further improve accessibility, we suggest adding fishing rod holders that are mounted at a variety of heights. This would allow people who cannot bend over or who cannot reach down to the dock to rest their fishing rods in the holders that best suit their needs.

Figure 33 A fishing rod holder at the dock level is less accessible to people with mobility- or balance-related disabilities.

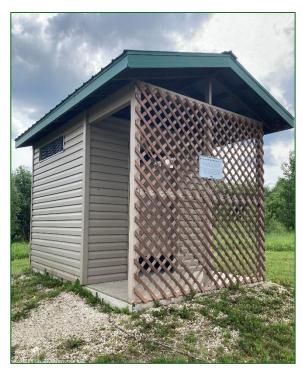
Washroom signage was inconsistent across the sites we visited. While many washroom sites had clear signage with standard washroom icons, some of the sites did not. In particular, the washroom at the Lac du Bonnet Trout Ponds has only a small text-based washroom sign instead of a universal washroom sign with icons. Depending on the design, visitors might confuse some public washrooms for sheds or utility buildings if there is no clear signage. Ensuring that all washrooms have clear and high-contrast signage will help prevent possible confusion.

Figure 35 The public washroom at the Lac du Bonnet Trout Ponds could be mistaken for a shed because it lacks clear signage.

• Clearly label washroom facilities with high-contrast signage so that they can be identified from a distance.

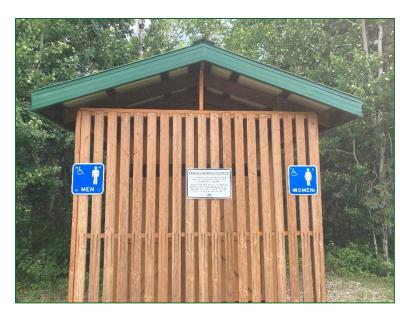
Figure 36 In contrast, the washrooms at the Wood Duck Boat Launch have clear signage identifying them as public washrooms.

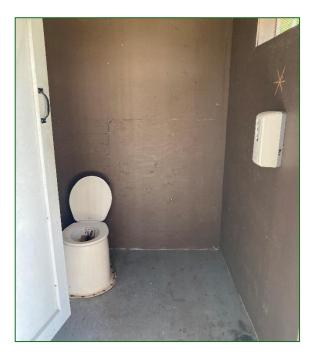
We noticed significant differences in the amount of light in the different washroom spaces across the RM. While in some cases this was related to the positioning of the washrooms in shady versus sunny spots, or the availability of small windows at the ceiling level, we found that the biggest factor was the interior colour of the washroom stalls. Washroom stalls that were painted white inside felt airier and easier to navigate compared to washrooms painted brown inside, even if they were the same size and layout, because they reflect whatever light is available. This small change can help make the washroom spaces easier to navigate on cloudy days or closer to dawn and dusk hours.

Figure 37 The interior of the washroom stalls at the LaVerendrye site are painted dark brown.

Consider painting the inside of washroom stalls white so that they reflect light and increase visibility.

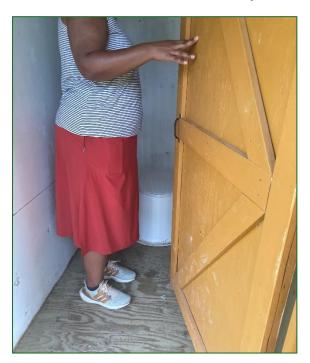
Figure 38 Even though the washroom stalls at Halliday Park are small, they feel brighter because they are painted white inside.

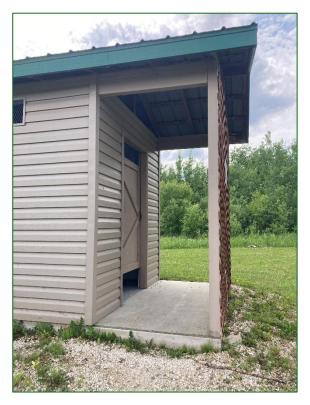
We noticed that each washroom across the RM has different fixtures and amenities, and that the installation and maintenance at each site varies similarly. While not all washroom facilities can be made maximally accessible due to geographic and resource constraints, fixtures like grab bars, toilet paper dispensers, and hand sanitizer dispensers should be considered essential components of every site's washroom facility.

Figure 39 There was no hand sanitizer dispenser at the Lac du Bonnet Trout Ponds public washroom facilities when we visited.

Ensure that all washrooms have appropriate fixtures like grab bars, toilet paper dispensers, and hand sanitizer dispensers, and that these are installed within safe reaching distance.

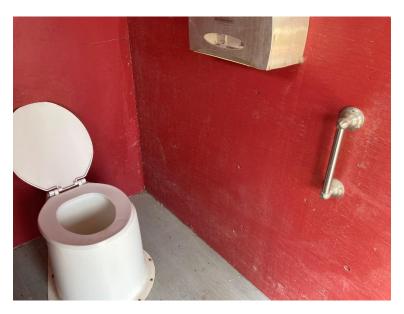
At some sites, we noticed what appear to be towel bars installed as grab bars in washroom stalls. While every washroom should have a grab bar, towel bars are not appropriate substitutes because they have a slippery texture and generally do not have the structural integrity to support a person's weight as they lean on the bar. We also noticed that many of the grab bars are installed far from the toilets, out of the reach of a person who would need them. We encourage the RM to source appropriate grab bars and to ensure that they are installed in a safe position in every washroom.

Figure 40 The Osprey Boat Launch washrooms appear to have towel bars installed instead of actual grab bars. The grab bars are also installed far from the toilets, out of the reach of many people.

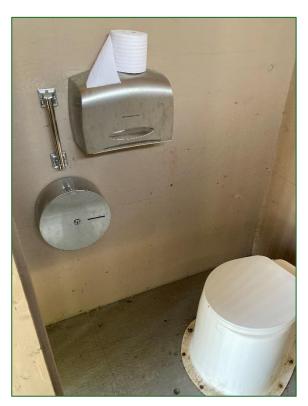
Figure 41 Towel bars are being used as grab bars at the Halliday Park washrooms. They are installed behind the toilet paper dispensers, so they are out of reach of anyone who needs them.

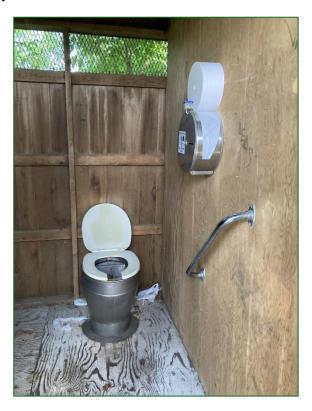
At other sites, we noticed that the toilet paper dispensers are installed too high or too far away from the toilets. Access to toilet paper is essential in washroom facilities, and we recommend that all toilet paper dispensers be inspected and adjusted to ensure that they are within safe and easy reach of the toilets.

Figure 42 The toilet dispensers in the Winnipeg River Boat Launch washrooms are installed high on the walls, outside of the reach of many people when seated on the toilet.

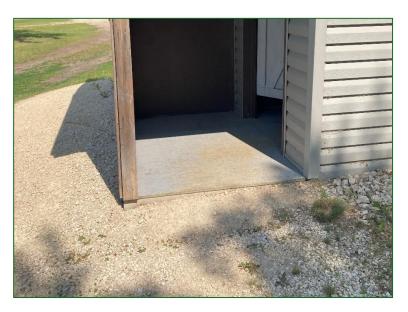
Several washrooms also have steps or lips between the platforms and the ground. As we noted with respect to the boat launch docks, potential solutions could be refreshing the gravel and landscaping, installing transfer ramps, or redesigning the platforms to connect smoothly with the ground.

Figure 44 The entrance to the public washrooms at the LaVerendrye site. There is a lip between the edge of the platform and the gravel underneath that creates a barrier for people using mobility aids.

- Repair ramps, platforms, and paths leading to washrooms to ensure safe access by people using mobility aids and wheelchairs.
- Ensure that public washrooms are regularly maintained and repaired as needed to prevent obstacles arising due to wear and tear.

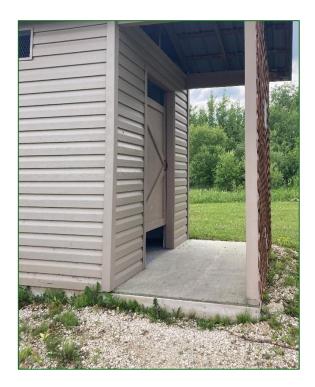
Figure 46 The path leading to the Lac du Bonnet Trout Ponds washroom is uneven and there is a step up onto the washroom platform.

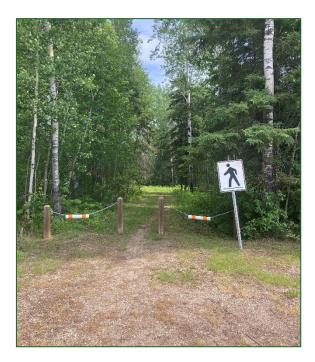
Figure 48 It is not clear that this is the trailhead for the Cape Coppermine Road trail because there is no trail-related signage.

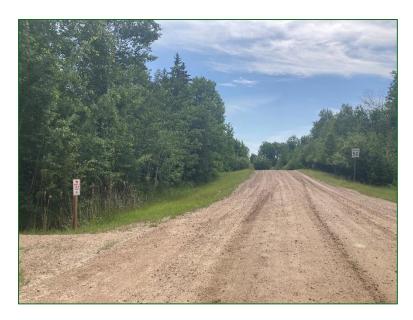
When we started our hike along the Cape Coppermine Road trail, we thought that we might be walking through a vacant lot until we saw a sign across the next street with a small RM icon. We then realized this was a trail marker. We saw these trail markers again throughout our walk as we crossed intersecting roads, but we found ourselves getting confused about how far we had walked because each sign and intersection looked very similar. The next time these signs are being replaced, consider choosing larger signs that clearly note the trail name and, if possible, the intersecting road. Another option would be to choose an easily recognizable symbol or icon for each individual sign to help distinguish the different milestones along the trail. In the event of an emergency, having clear signage to use as a landmark would also help someone calling 911 to accurately communicate their location.

Figure 49 The signs marking the trail along intersecting roads are not legible from a distance.

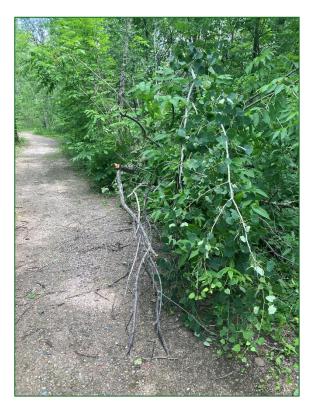
Figure 50 Broken branches, like this one on the Cape Coppermine Road trail, can create barriers for people with disabilities accessing the trails.

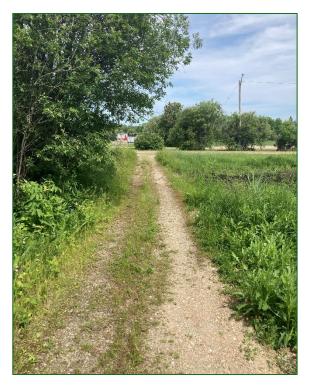
Figure 51 Grass and foliage growing into the surface of part of the Cape Coppermine Road trail makes the space on the trail narrower.

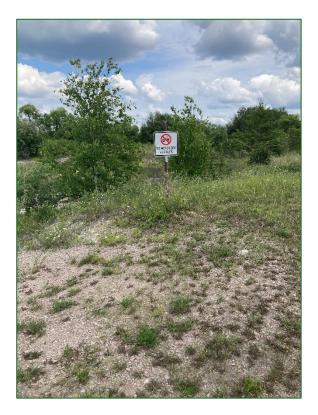
Figure 52 This sign marks the end of the more accessible part of the Lac du Bonnet Trout Ponds trail. The sign does not say that the trail becomes rocky after this point.

We have included resources for designing accessible trails and trail wayfinding systems, including the Trans Canada Trail's All Persons Trail guidelines, in Appendix G to this report.

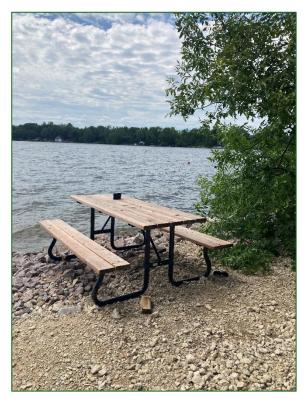
Figure 53 This picnic table at the Fernwood Boat Launch park site is positioned on large rocks and very close to the water. It is also very close to a group of shrubby trees, making safe access to the table challenging.

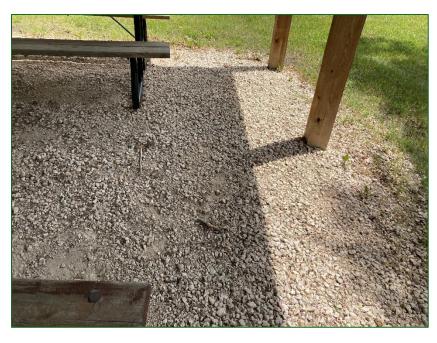
Figure 54 The gravel under the picnic area at Fernwood Park is mostly even, but it appears to have loosened due to weather and foot traffic.

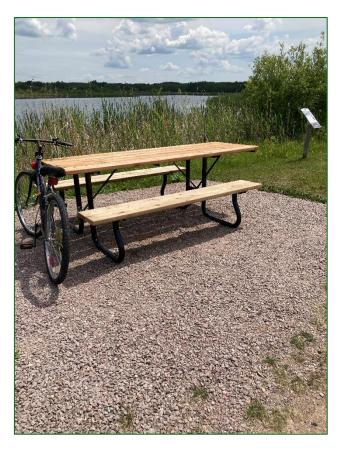
Figure 55 The gravel under this picnic table at the Lac du Bonnet Trout Ponds site is even and well-packed. The site is also clear of potential obstacles.

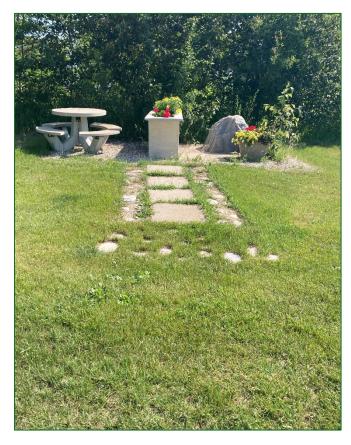
Figure 56 A decorative planter has been placed at the end of the path between the parking lot and the picnic area at the LaVerendrye site.

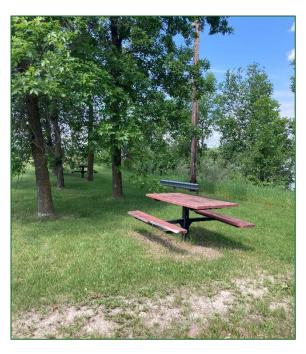
The picnic tables at the Winnipeg River Boat Launch site are reaching the end of their usable life and their wooden surfaces are wearing away. The seat on at least one picnic table has broken due to heavy use. We encourage the RM to inspect existing picnic tables and to schedule maintenance, repairs, or replacements as they are needed.

Figure 57 The picnic tables at the Winnipeg River Boat Launch site are breaking down due to wear and tear.

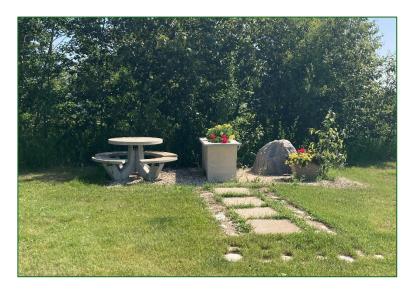
Figure 58 This picnic table at the LaVerendrye site is not accessible to people using wheelchairs or walkers. It would also pose a barrier for a person who has difficulty lifting their legs to manoeuvre onto the seat.

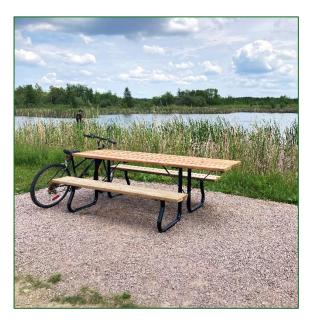
In contrast, some of the picnic tables and benches at other sites are clearly newer and well-maintained. Several of the picnic tables at the Lac du Bonnet Trout Ponds site have been designed to accommodate people using wheelchairs, so that a wheelchair user could use the table equally alongside their friends or family members. We suggest that the RM consider purchasing more of these picnic tables in the future for installation at other sites.

Figure 59 This picnic table near the parking lot of the Lac du Bonnet Trout Ponds has an extended tabletop that is accessible to people using wheelchairs.

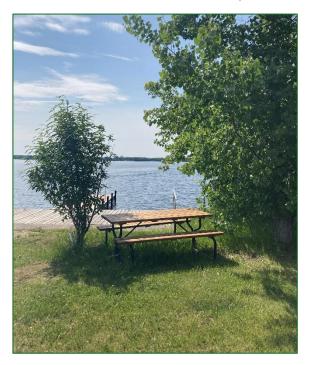
Figure 61 The trees close to this picnic table at the LaVerendrye site provide good shade, but they should be trimmed so that they do not impede access to the picnic table. The picnic table could also be rotated for more space between the table and trees.

Consider opportunities to provide shade by strategically planting trees or adding gazebo structures.

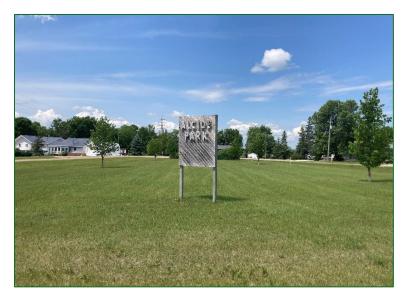
Figure 62 The RM has opportunities to add shade trees and shelters as Alcide Park is developed.

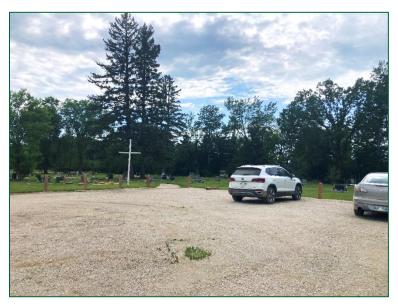
Figure 63 The parking lot at the Riverland Cemetery is clear, flat, and spacious.

In our opinion, the Riverland and Lee River cemeteries are the best examples of accessible parking areas among the RM's cemeteries. These sites can be used as inspiration for pursuing upgrades to the parking areas in other locations.

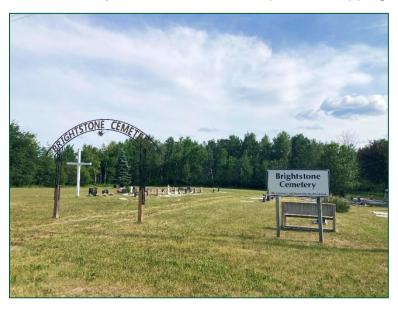
Figure 64 The Brightstone Cemetery has mostly flat ground, but it does not have a cleared or packed path.

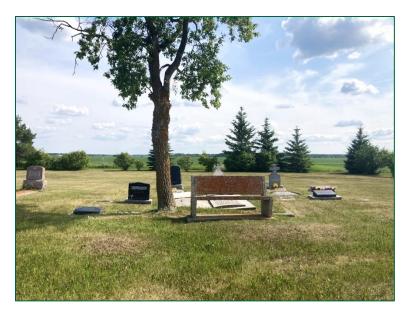
Figure 65 A well-positioned bench and tree at the Red Deer cemetery.

In our opinion, the Riverland and Red Deer cemeteries provide great examples of using benches and shade to improve aesthetics and accessibility.
